Toms Creek Watershed Plan Report

TOWN OF WAKE FOREST
FEBRUARY 2024

LJB Engineering PC

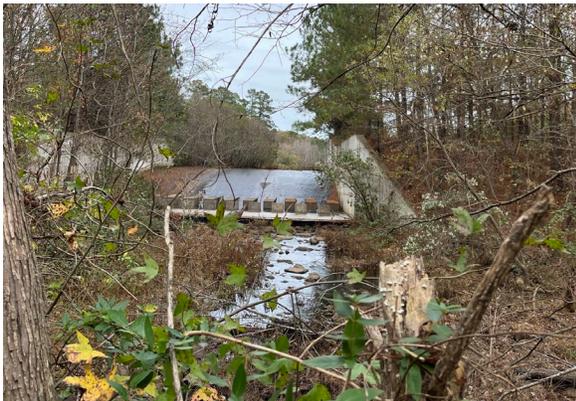
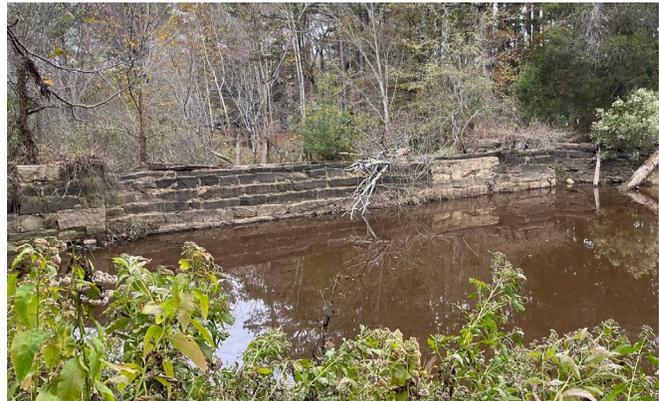
Figure 7. Browns Lake Dam and Masonry Dam above Browns Lake

The project focus area also includes Browns Lake and dam, as well as a smaller upstream dam. The dam at Browns Lake is rated by NC Dam Safety as high hazard. The lake has a surface area of about 8½ acres at the normal pool elevation. The dam is earthen with a concrete spillway chute as the main outlet. Additionally, there is a smaller masonry dam at the upstream end of Browns Lake. There are extensive wetland areas along Toms Creek from the smaller dam upstream to the Forestville Road culvert crossing and beyond.

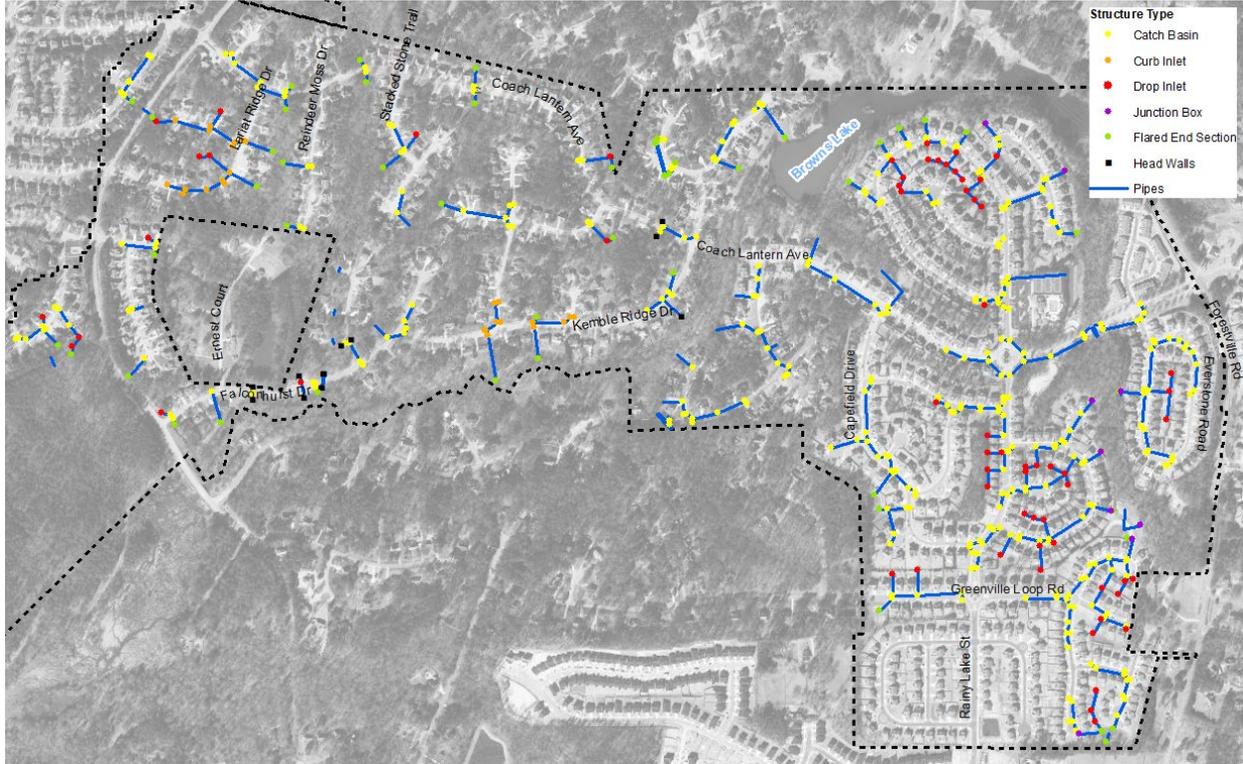
Figure 8. Drainage System Map

and verification performed by LJB, it is estimated that the closed system consists of 420± “hard” drainage structures (e.g. catch basins, manholes, etc.) and 6.9± miles of connected pipes within the focus area. A significant majority (70%+) of the pipes are relatively small (≤ 18 ”). The largest pipe size is 54” and there are only a handful of pipes that are 48” or greater. There are two primary bridges where Toms Creek passes under Ligon Mill Road and Coach Lantern Avenue. Figure 8 illustrates the drainage infrastructure within the watershed and Tables 3 and 4 list the pipe lengths and structures.

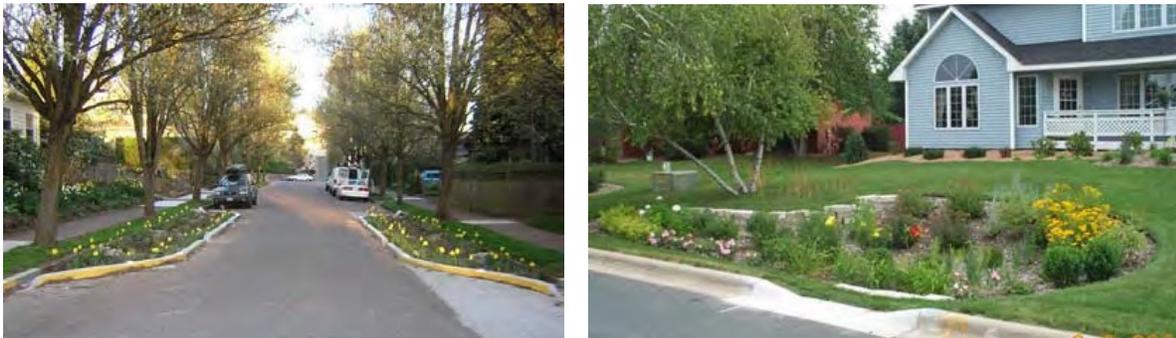
Figure 14. Examples of Green Streetscaping

For the western portion of the focus area, where neighborhoods were built before post-construction stormwater controls were required, the street rights-of-way are the only publicly owned or community-shared spaces available for locating SCMs to provide some water quality treatment. Several of the streets are wide enough to accommodate “green streetscaping” near sag points, with bioretention areas built out into the street at about the width of a parked car and back into the area behind the curb. Gutter flows would be directed to the bioretention area for treatment before discharge into the drainage pipe, with overflows beyond the SCM capacity routed directly to the curb inlet downgradient. The photos below show concepts for an SCM partially within the street and one within right-of-way behind the curb.

Several of the streets in the western areas of the watershed are wide enough to accommodate “green streetscaping” near sag points, with bioretention areas built out into the street at about the width of a parked car and back into the area behind the curb. This would help to provide some water quality treatment for neighborhoods where no Structural Control Measures (SCMs) for stormwater were required when they were developed. In several areas along one tributary stream recommended for stream stability improvements, there is enough area outside of required buffers for installing new SCMs to better protect water quality and stream stability.

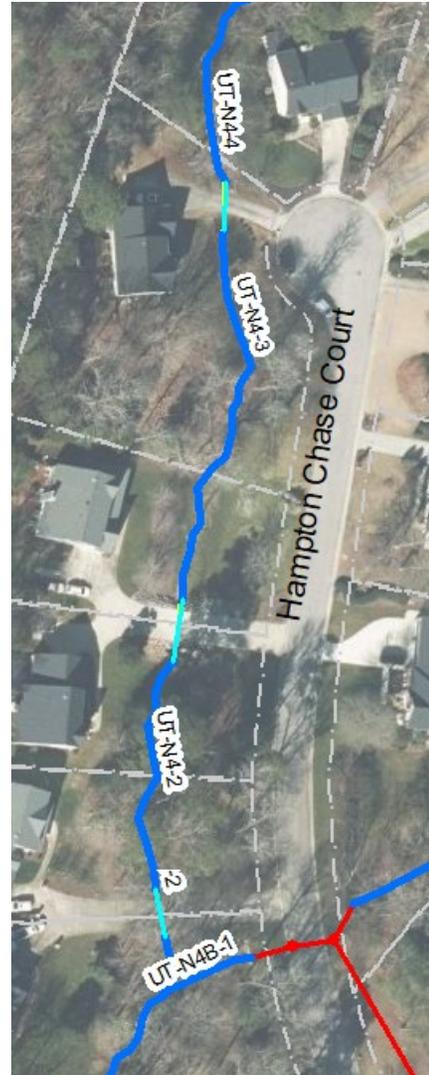
Replace three existing 48” CMP culverts under driveways along Hampton Chase Court due to deterioration in the bottom of the pipe. Recommendation is to replace with 54” HDPE buried 6” below stream bed for increased flow conveyance and improved aquatic passage.

1. Given that these pipes are on private property and not within a public right-of-way, the Town will need to determine if and to what extent the Town will participate and/or manage replacement of the pipes.
2. The pipes adequately convey 4% annual chance peak flows, though not without significant backwater effects. Floodwaters are projected to impound against the structure upstream of the northernmost driveway crossing before it is overtopped.
3. A more detailed inspection of each pipes may determine that not all of them need to be replaced at this point and it may be beneficial for the Town and/or preferred by property owners to selectively replace as vehicular safety starts to become compromised.
4. Approvals would be expected for 404/401 permits for stream and wetland impacts under NWP 3 for maintenance.
5. Maintenance of emergency access to impacted homes.

Approximate Cost: \$190,000 (includes design, permitting, and construction) for replacement of three pipes.

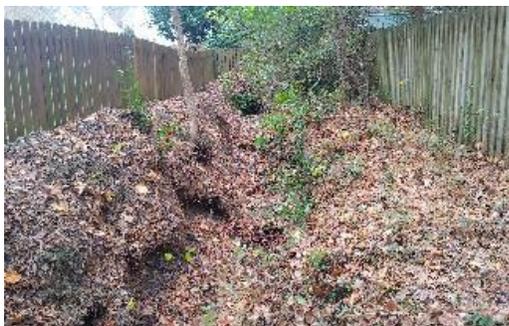
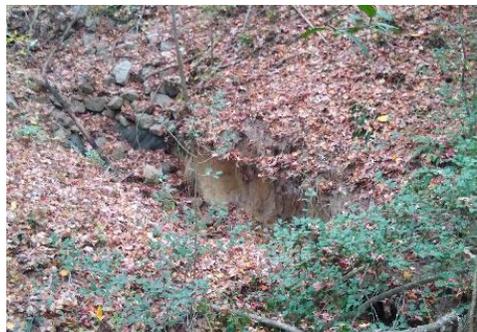
As an alternative, recommended target areas would be at the pipe discharge points along the reach. Specifically the areas circled in red would be stabilized with energy dissipation pools at pipe outlets and stabilized stream reaches. Benefit score is 4 and Access score is 4.

Project 01: \$610,000 (includes design, permitting, and construction)

Project 01A: \$250,000 (includes design, permitting, and construction)

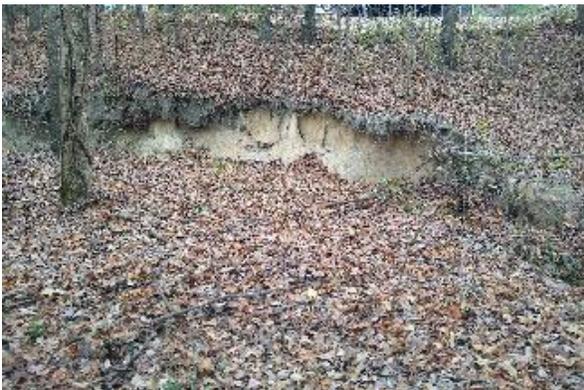
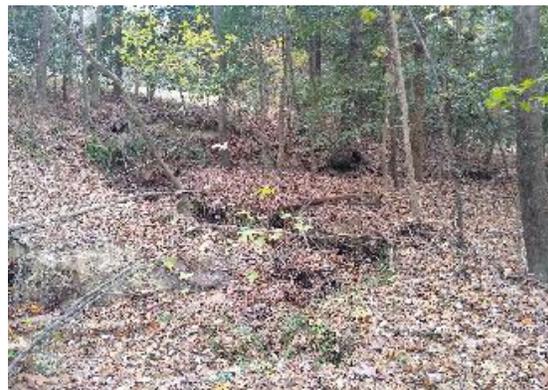
Project ID:
TC-ER-02

1. Buy-in from County property owners where the Town has no easements or jurisdiction.
2. 404/401 permit for stream and wetland impacts.
3. Permanent and temporary easements along stream.
4. Easements for access and staging areas.

Approximate Cost: \$500,000 (includes design, permitting, and construction)

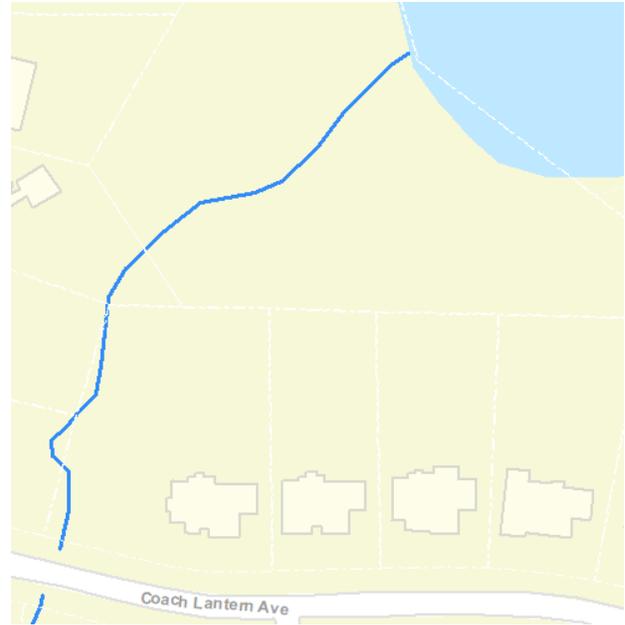
Project ID:
TC-ER-03

Stream restoration for improved energy dissipation and bank stabilization to reduce further impacts to private backyard areas and to downstream areas. Project will include improved dissipation below the dam and a series of boulder steps or cross vanes as drop structures to reduce velocities through the reach and under the bridge. It is expected that only minimal floodplain benching can be accomplished with this project. Benefit score is assigned as 1 due to severity of ongoing erosion and Access score is 3 since there are relatively few affected owners.

Between Browns Lake dam and Coach Lantern Avenue bridge

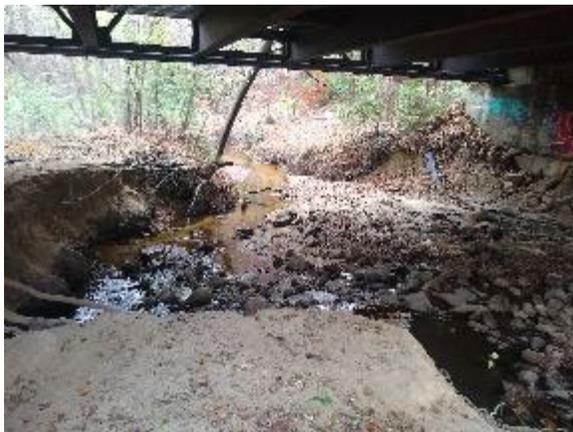
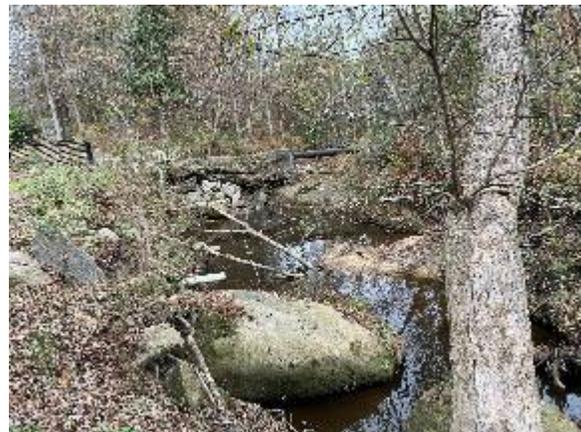
1. 404/401 permit for stream and wetland impacts
2. Permanent and temporary easements along stream
3. Easements for access and staging areas

Approximate Cost: \$360,000 (includes design, permitting, and construction)

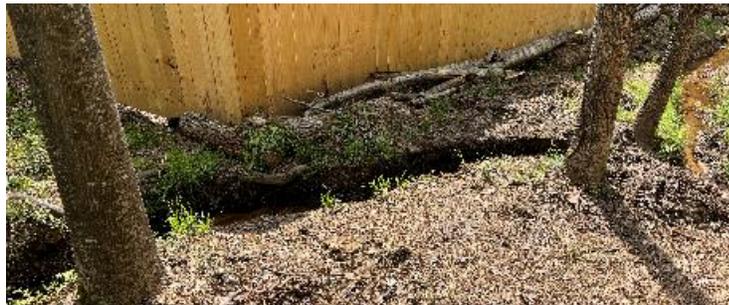
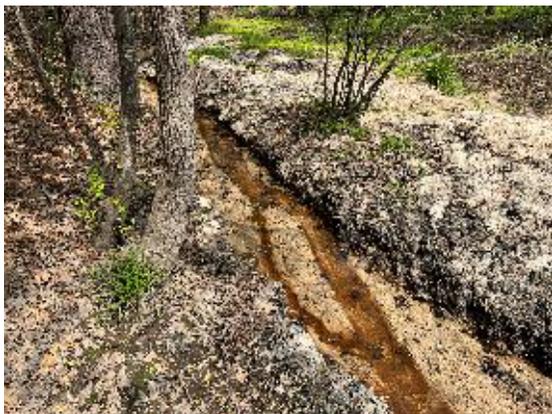
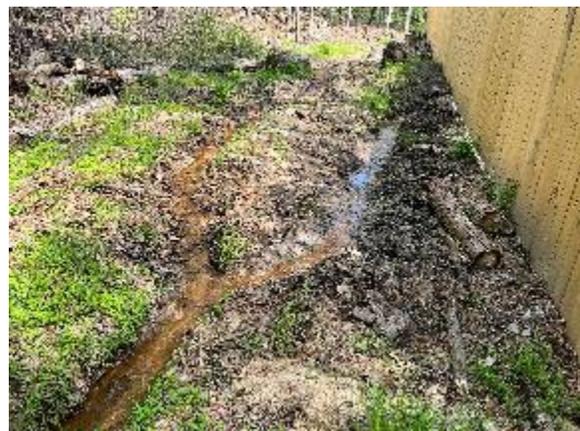
Project ID:
TC-ER-04

1. 404/401 permit for stream and wetland impacts
2. Permanent and temporary easements along stream
3. Easements for access and staging areas

Approximate Cost: \$180,000 (includes design, permitting, and construction)

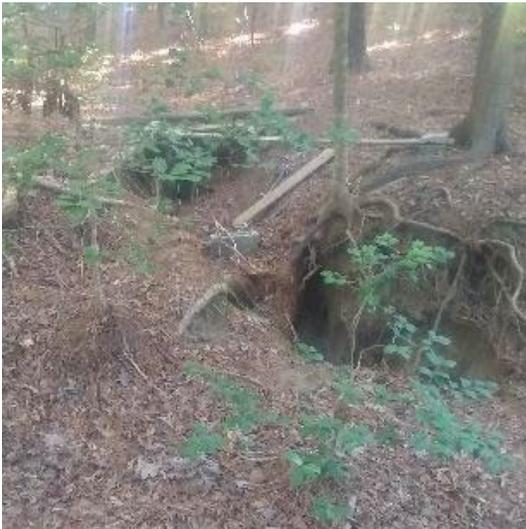
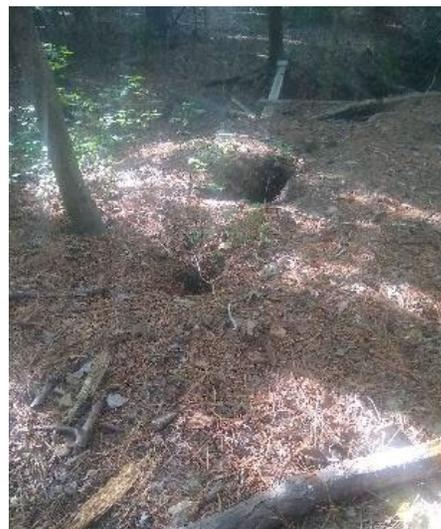
Project ID:
TC-ER-06

1. 404/401 permit for stream and wetland impacts.
2. Permanent and temporary easements along stream.
3. Easements for access and staging areas.

Approximate Cost: \$270,000 (includes design, permitting, and construction)

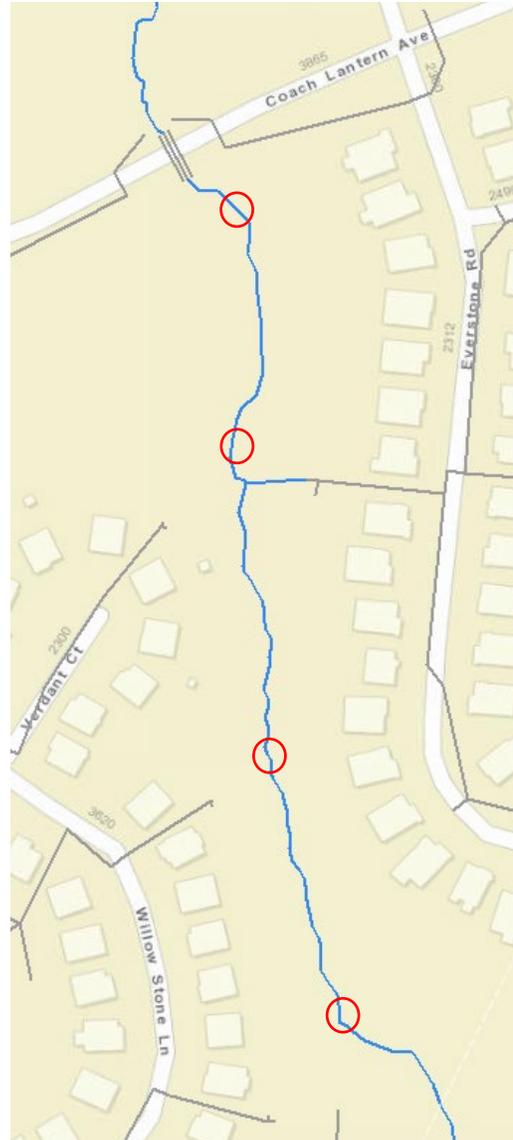
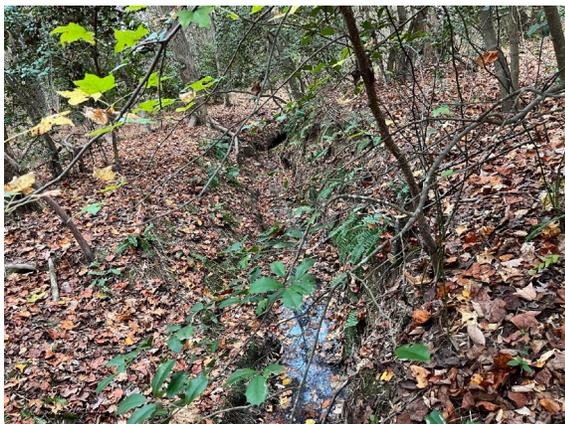
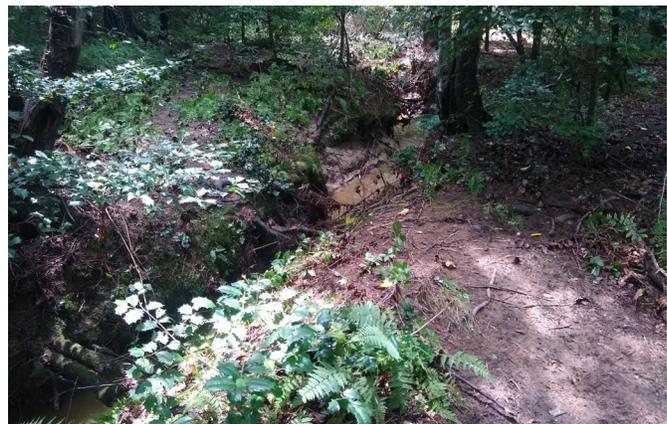
Project ID:
TC-ER-07

1. 404/401 permit for temporary stream and wetland impacts for ecological protection and enhancements within a conservation easement.
2. Agreements with the HOA and developer for project implementation.
3. Notifications to property owners of planned access through existing drainage easements.

Approximate Cost: \$240,000 (includes design, permitting, and construction)

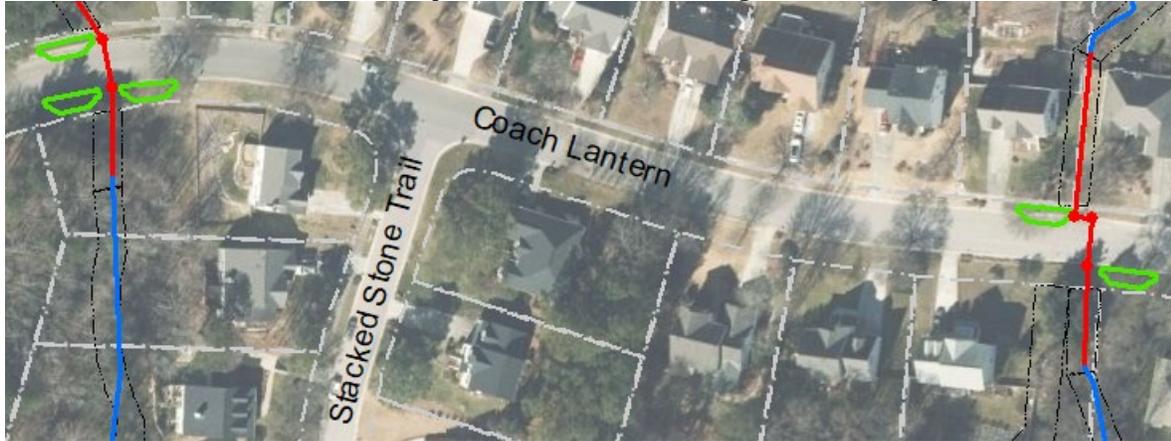
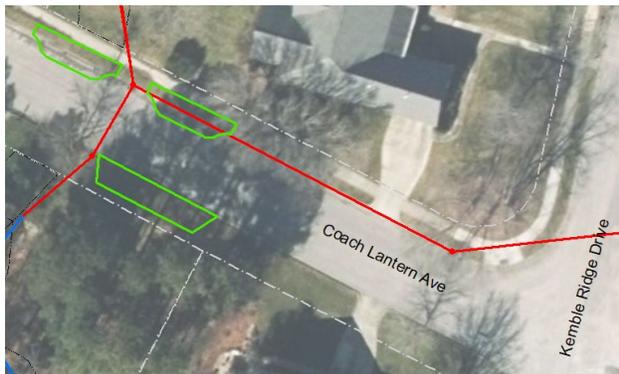
Project ID:
TC-WQ-01 Green Streetscaping on Coach Lantern Avenue

Recommended SCM locations and potential sizes shown in green on aerial photos below.
